SPD 10006 – FM KHUSAT-03

Vibration Testing

This document provides the vibration test procedure of SIGMA FM (Acceptance Model) by falcon 9 environment data. The sine sweep vibration test and random vibration test will be conducted at KAIST Satellite Research Center in Korea as SIGMA FM vibration test.

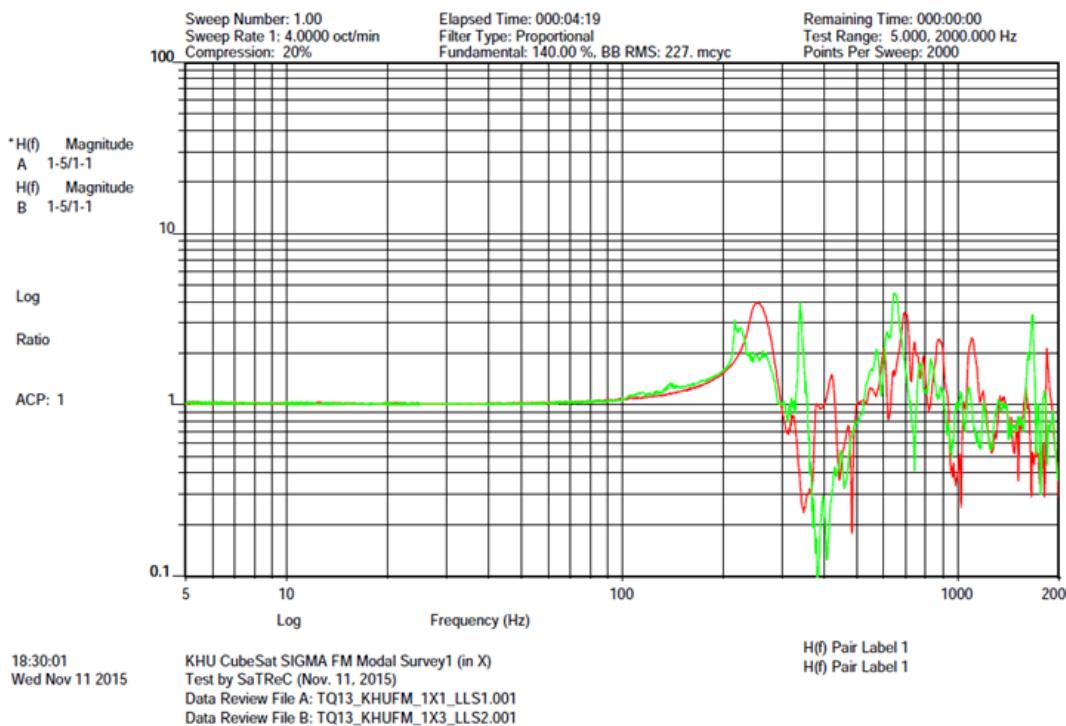
Figure 13. Comparison of natural frequency about pre sine sweep vibration and post sine sweep vibration test on ch 5 (X axis)

After vibration test of X axis, weak noise was checked inside the SIGMA during function test. Same noise was reproduced when the SIGMA position was changed for several times. Inspection of inside was conducted after + Z chassis of SIGMA was disassembled. Then, cause of noise was checked as it of inside TEPC. We decided this issue is not effects other systems, so conducted remaining proceed of vibration test after re-assemble from next day.

By comparing response data of PRS and POS, change of their natural frequencies was checked. During random vibration test of X axis, mechanical problem of TEPC was happen and that problem caused to generate differentness with PRS and POS. For more details about TEPC issue refer to Appendix A.

Axis	Test type	Natural frequency	Remarks
X	PRS	250.6 Hz	N/A
	RV	N/A	
	POS	215.7 Hz

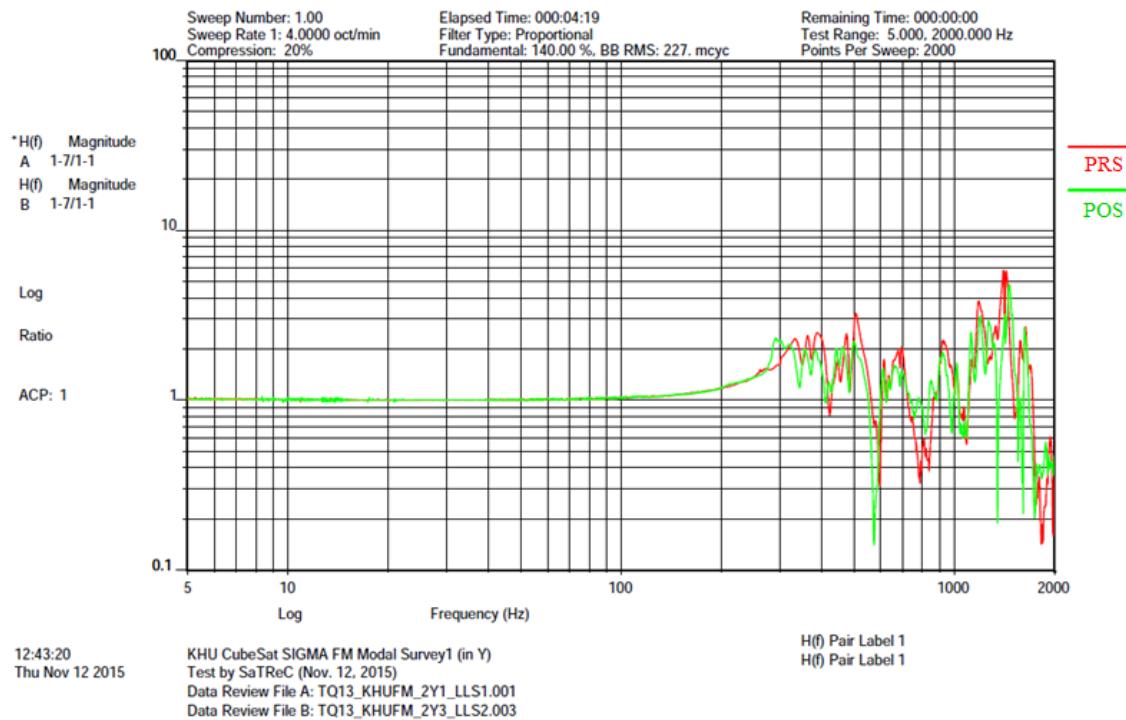
Figure 18. Comparison of natural frequency about pre sine sweep vibration and post sine sweep vibration test on ch 7 (Y axis)

Also PRS and POS of Y axis are effected by TEPC issue. By comparing response data of each test, change of their natural frequencies was checked. On the other hand, overall graph shape was similar with PRS and POS than other test results due to BRF of Y axis.

Axis	Test type	Natural frequency	Remarks
Y	PRS	332 Hz	N/A
	RV	N/A	
	POS	291 Hz

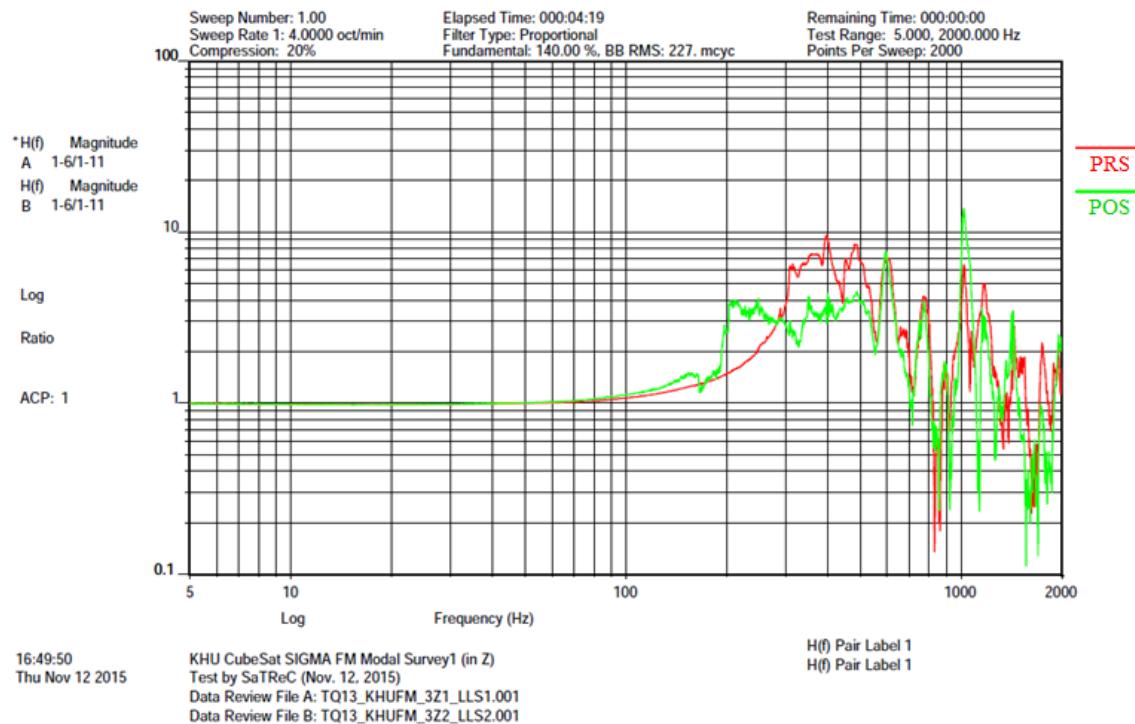
Figure 23. Comparison of natural frequency about pre sine sweep vibration and post sine sweep vibration test on ch 7 (Z axis)

Axis	Test type	Natural frequency	Remarks
Z	PRS	314 Hz	N/A
	RV	N/A	
	POS	211 Hz

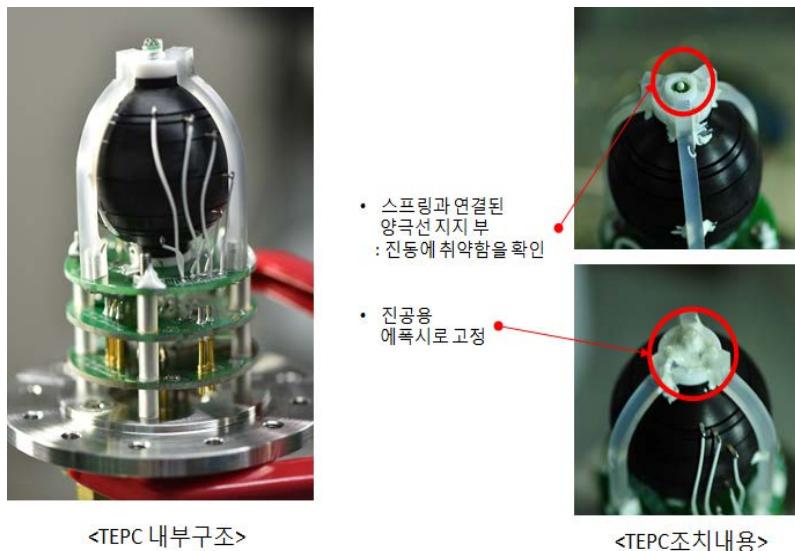
1. 진동 시험 요약

Figure 24 TEPC 내부구조(좌)와 재조립 후 조치사항(우)

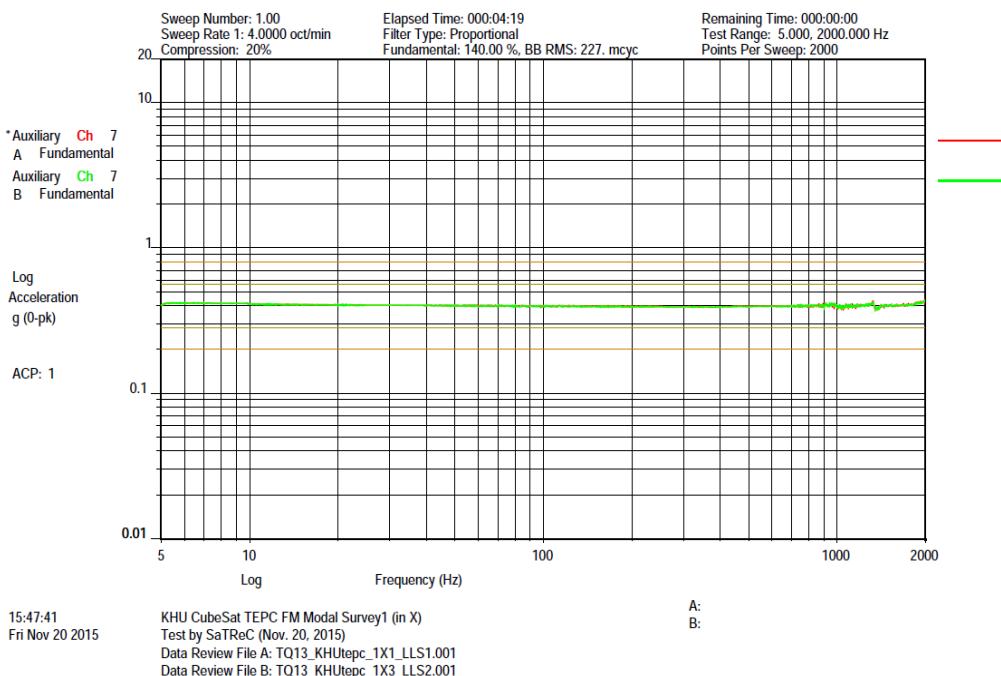
각 축 시험의 결과는 아래 표에서 정리되었으며, 각 축의 진동시험 프로파일은 아래 그림에서 보는 것처럼 random 진동시험은 요구사항인 10g RMS 값으로 진동되었고, 모달 서베이 전후 결과는 구조적으로 변화없는 것으로 확인되었다. 탑재체의 Mass가 매우 적고, 치구의 Mass가 대부분을 차지하고 있는 형태여서, 탑재체의 자체 모드는 2000Hz 이하에서 보이지 않음을 확인했다. 각 축의 진동시험 전후에 육안 검사를 수행했으며 흔들었을 때 소리가 발생하지 않으므로 파손이 없음을 확인했다. 또한 전체 진동시험이 끝나고 전자부와 연결하여 기능시험을 수행했으며, 이 결과는 진동시험 전 결과와 비교해서 변화없음을 확인했다. 따라서, TEPC FM 진동시험은 통과한 것으로 확인하였다.

Figure 29. X axis Modal Survey Comparison

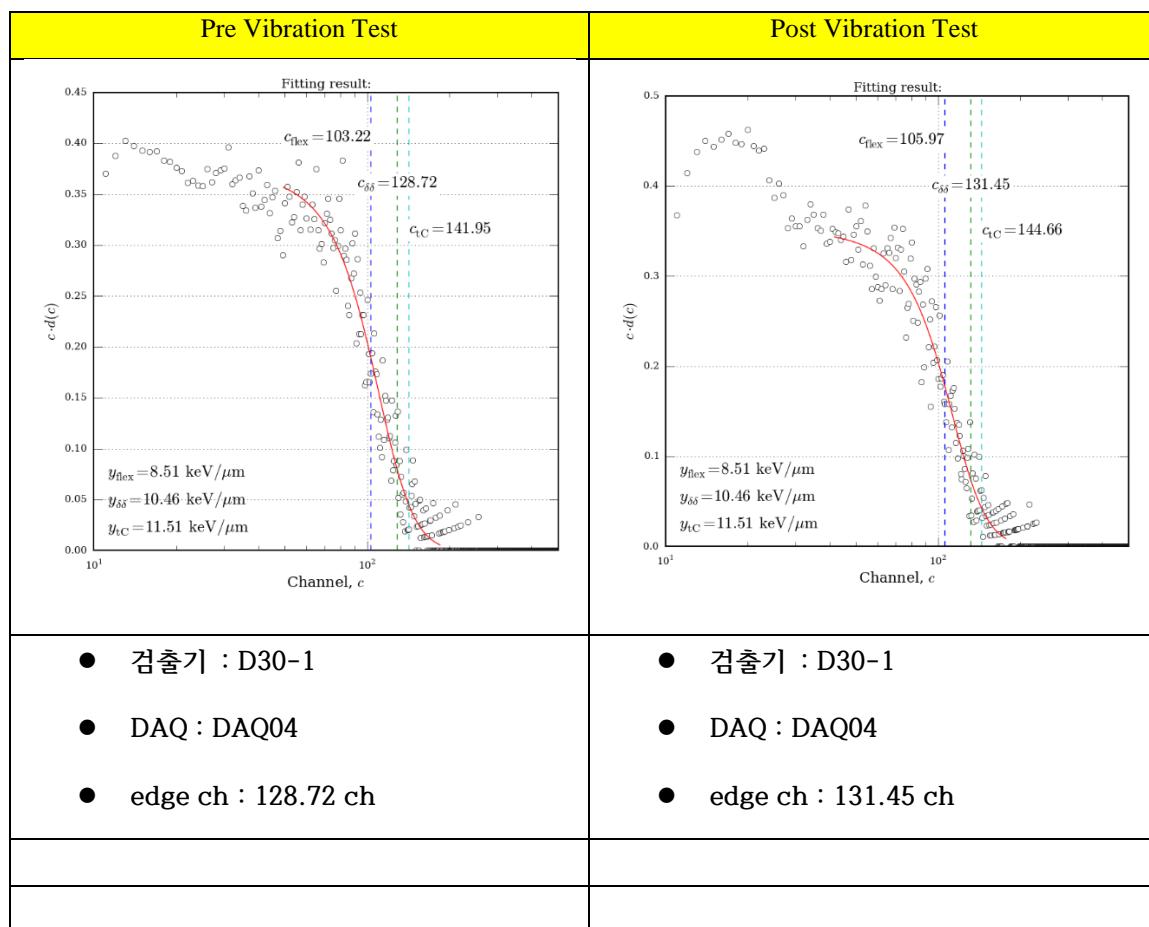
Table 23. Test Result of FM TEPC

- 진동시험 전, 후 electron edge값이 128.72채널(진동시험 전), 131.45채널(진동시험 후)로서 건의 같은 지점에서 측정되었음.
- 스펙트럼의 왼편편의 약간의 기울기 차이는 DAQ의 threshold 값 차이 때문임.
- 따라서 기능시험결과 진동시험 전, 후 성능변화가 없음을 확인 하였음.
