# SPD 10003 – QM Thermal Vacuum Testing

This document describes TVAC test procedure of the KHUSAT-03 for QM. TVAC test consists of thermal cycling test and thermal balance test. The objective of thermal cycling test is to verify the system performance under the thermal vacuum condition which the spacecraft will encounter in space. The objective of thermal cycling test is subject the KHUSAT-03 satellites to the temperature extremes that have been derived from the combination of thermal analysis results and component-level operational temperature ranges. Functional TVAC tests will be performed in a thermal vacuum chamber at the KHU.

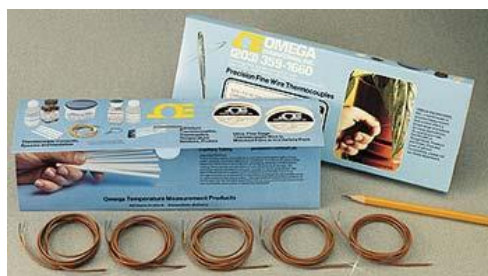
Omega Engineering 5TC-TT-T-30-36

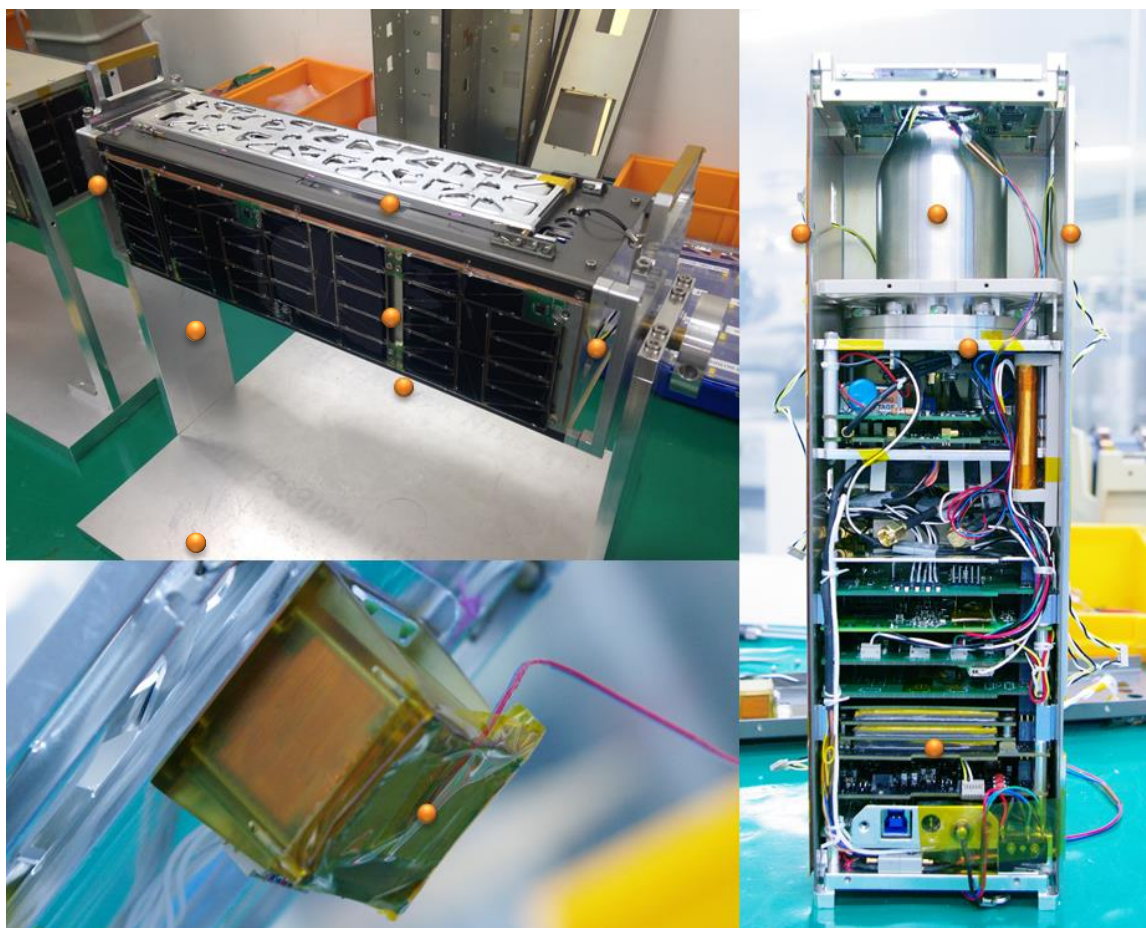
## 5.4 Location of Thermo Couples (QM)

| Thermo couple | Location | Thermo couple | Location |
| T1 | Shroud 1 | T2 | MAG Sensor |
| T3 | Battery | T4 | TEPC Mount |
| T5 | TEPC Chamber | T6 | UV ANT(+Y) |
| T7 | Chassis +X | T8 | Chassis -X |
| T9 | Chassis -Y | T10 | Chassis +Z |
| T11 | Chassis -Z | T12 | Shroud 2 |

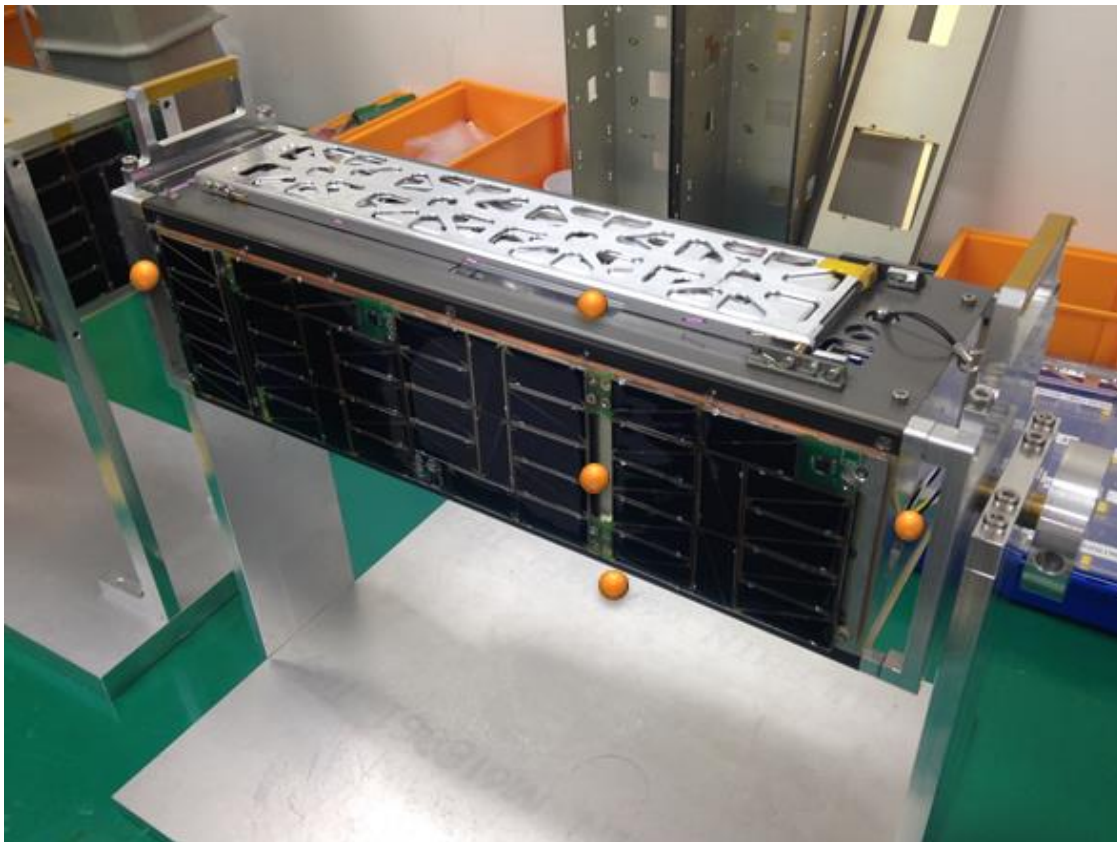
## 5.5 Location of Thermo Couples (FM)

| Thermo couple | Location | Thermo couple | Location |
| T1 | +Z Chassis | T2 | -Z Chassis |
| T3 (Optional) | +X Chassis | T4 (Optional) | -X Chassis |
