SPD 10006 – FM KHUSAT-03

Vibration Testing

This document provides the vibration test procedure of SIGMA FM (Acceptance Model) by falcon 9 environment data. The sine sweep vibration test and random vibration test will be conducted at KAIST Satellite Research Center in Korea as SIGMA FM vibration test.

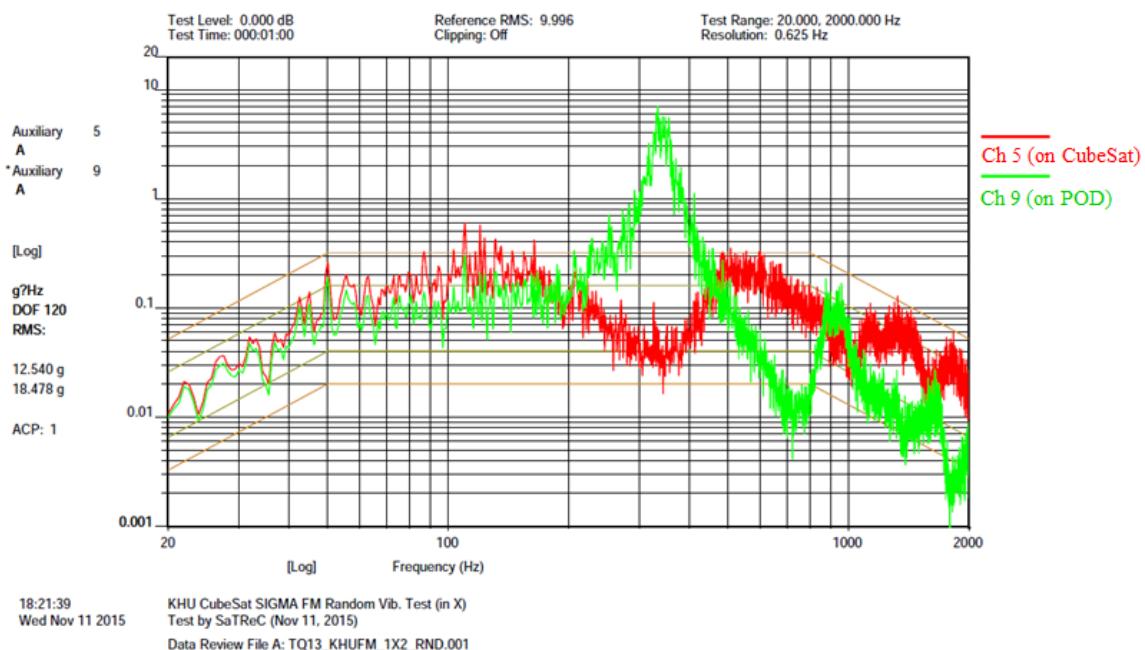
Figure 11. Random vibration test result (X axis)

After vibration test of X axis, weak noise was checked inside the SIGMA during function test. Same noise was reproduced when the SIGMA position was changed for several times. Inspection of inside was conducted after + Z chassis of SIGMA was disassembled. Then, cause of noise was checked as it of inside TEPC. We decided this issue is not effects other systems, so conducted remaining proceed of vibration test after re-assemble from next day.

By comparing response data of PRS and POS, change of their natural frequencies was checked. During random vibration test of X axis, mechanical problem of TEPC was happen and that problem caused to generate differentness with PRS and POS. For more details about TEPC issue refer to Appendix A.
